MEMORANDUM

SUBJECT: Petroleum Product Release – 741 S. Riverbend Dr., Douglas, WY

Bonanza Earth Removers, LLC / Big Country Storage
March 31, 2021 Inspection

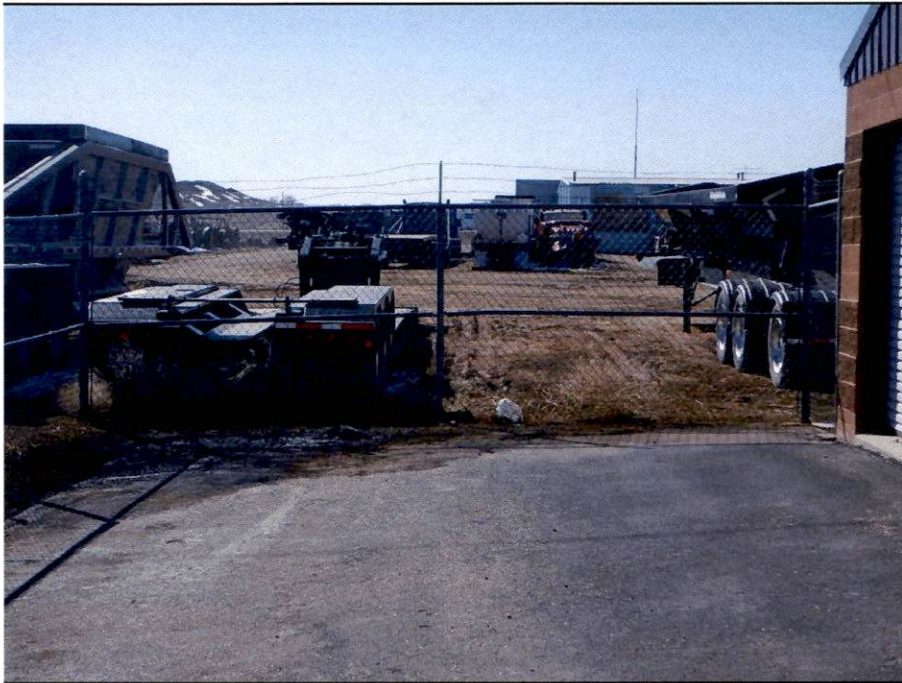
Photo 1 looks west from the southwest corner of the Big Country Storage property on to the lot owned by North Park Transport. Conversation with the Douglas Police Department indicates the east half of the lot is rented to Bonanza Earth Removers. Discussions with Douglas Emergency Management personnel indicate a tanker trailer was parked in the empty space shown.

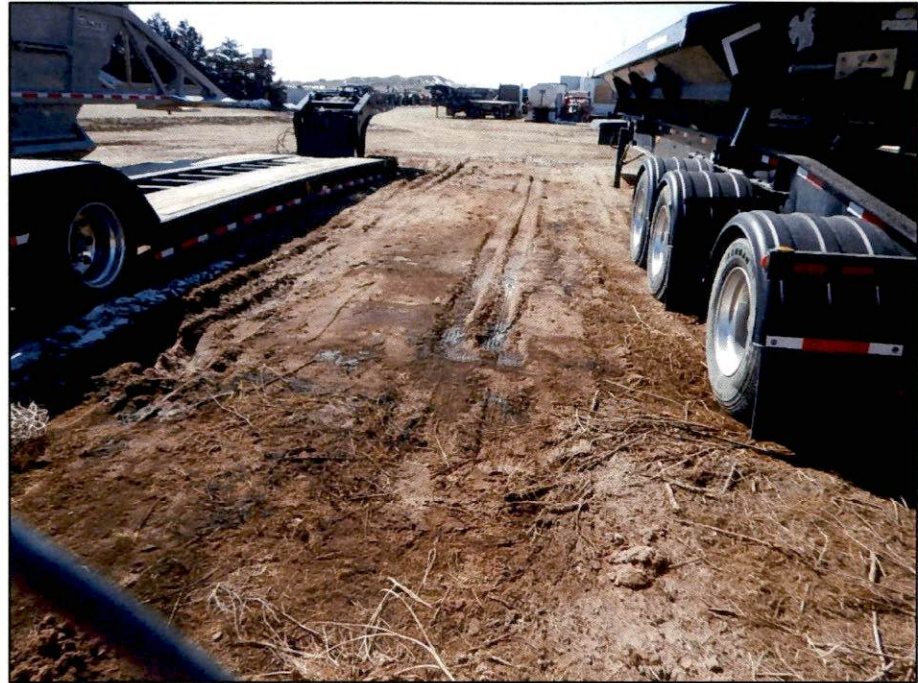
Photo 2 shows the contaminated soil in the area where tanker trailer was parked.

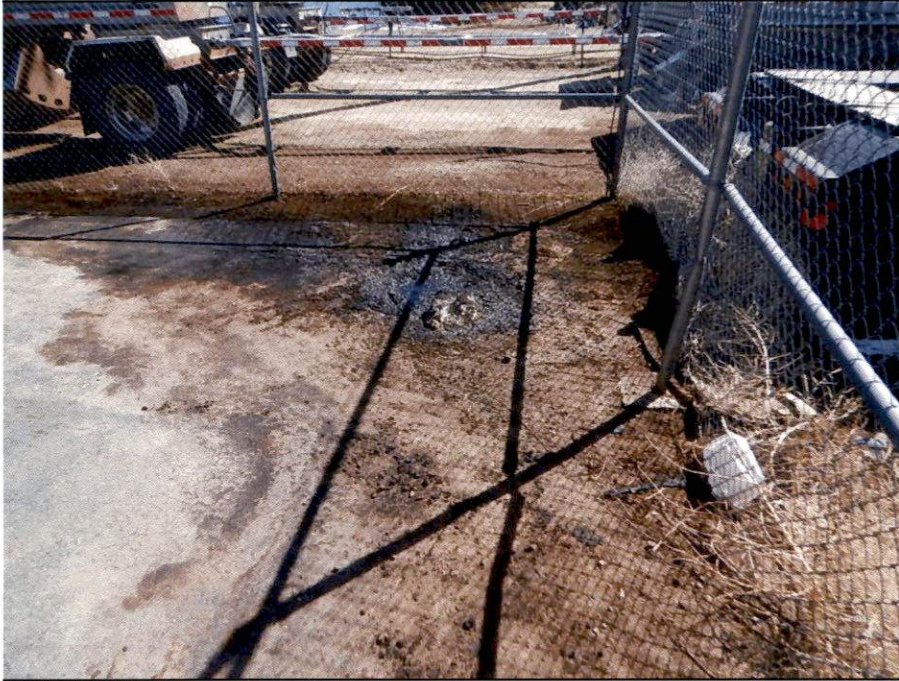
Photo 3 looks south at the southwest corner of the Big Country Storage property and petroleum product staining of the soil at this location.

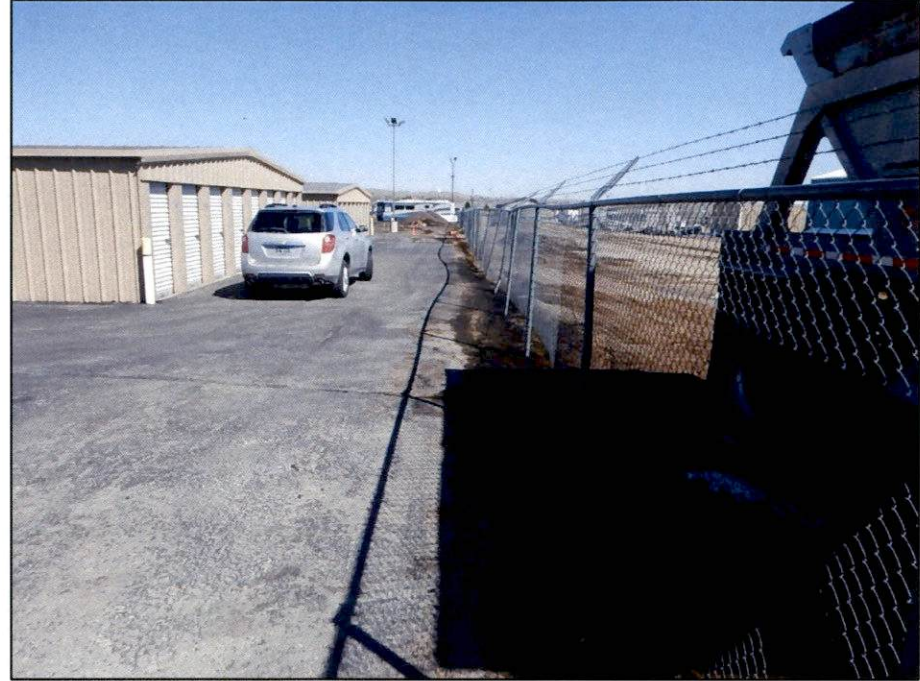
Photo 4 looks east along the south fence of the Big Country Storage property. The belly dump trailer shown at the right edge of the photo belongs to Bonanza Earth Removers. The petroleum product traveled along edge of the asphalt and down the fence line.

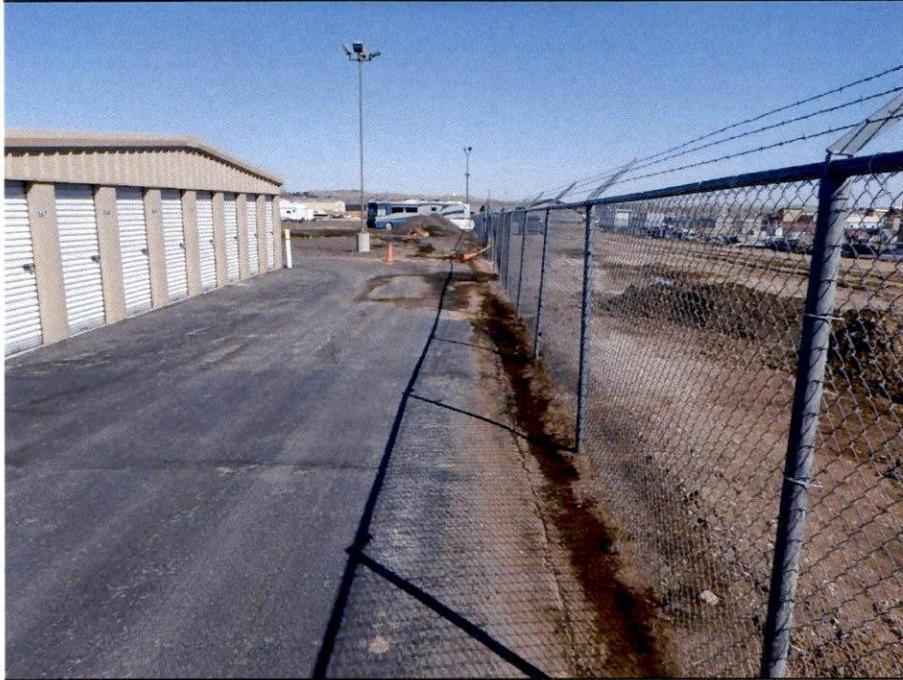
Photo 5 looks east along the south fence of the Big Country Storage property at a location opposite the middle and east storage buildings. Note the petroleum stained soils as well as asphalt in some areas.

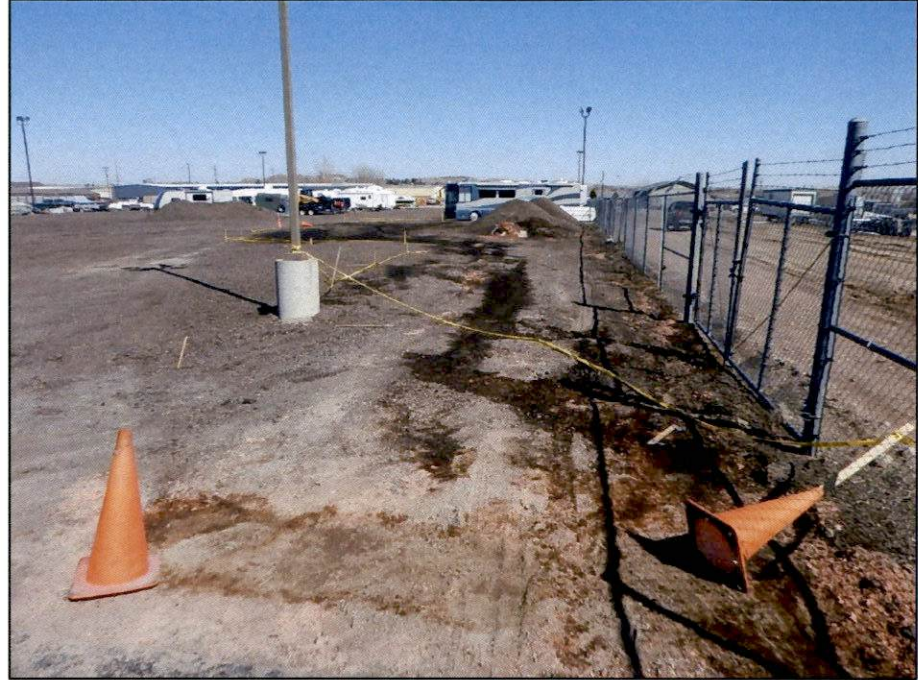
Photo 6 looks east from about the edge of the pavement on east side of the east storage building on to a lot used to store RV's, etc. The lot appears to be owned by the same individual that owns Big Country storage based on information obtained from the county map server.

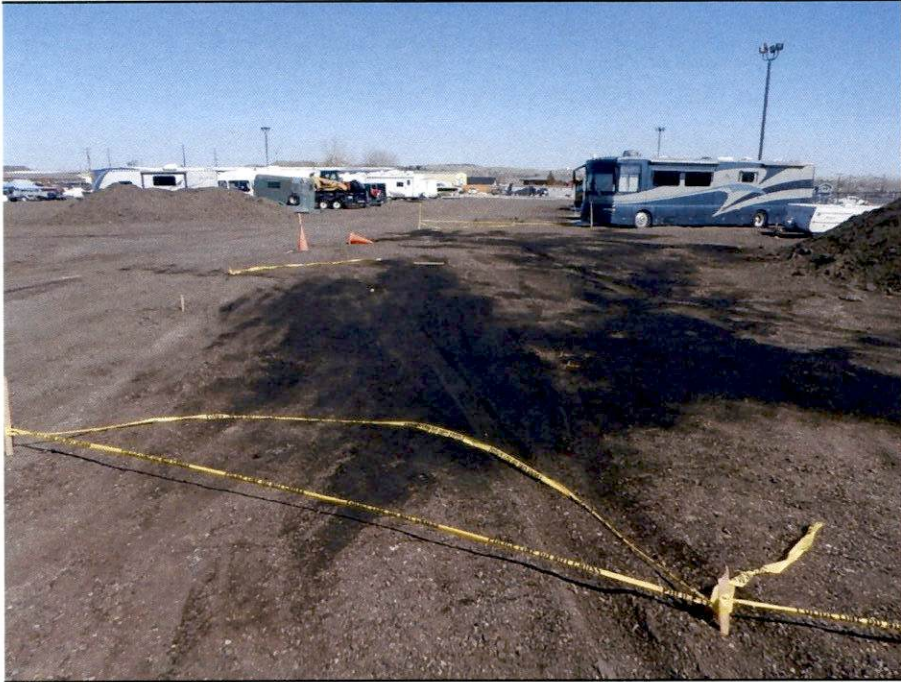
Photo 7 looks east and shows the general area of petroleum contaminated soils in the lot east of Big Country Storage.

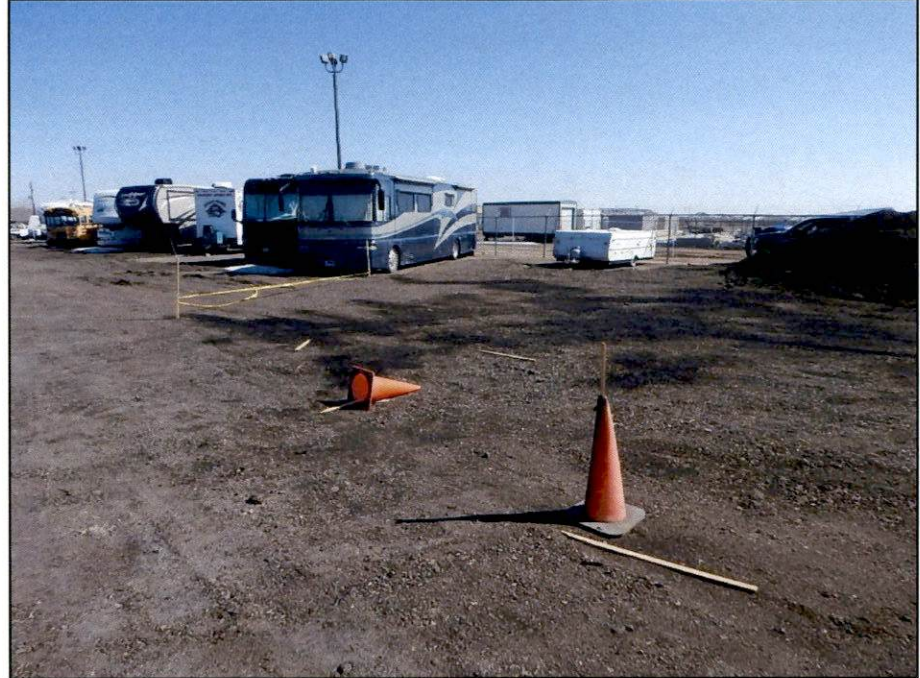
Photo 8 looks southeast and shows more of the contaminated soils as shown in Photo 7.
